# **THE CALIFORNIA EARTHQUAKE OF 1906**

The  
California Earthquake  
of 1906

*Edited by*  
David Starr Jordan

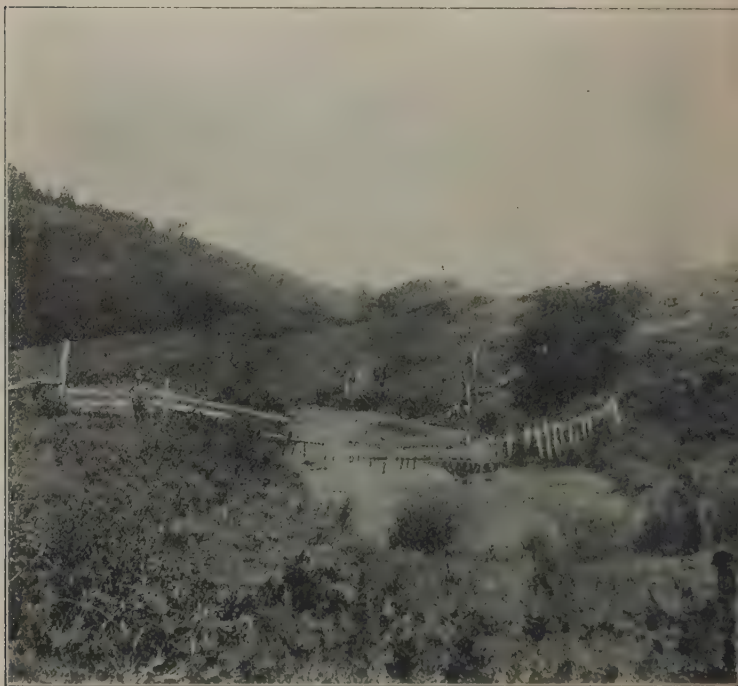
• *Earthquake Rift, As It Comes up from the Sea at Point Arena, Mendocino County.*

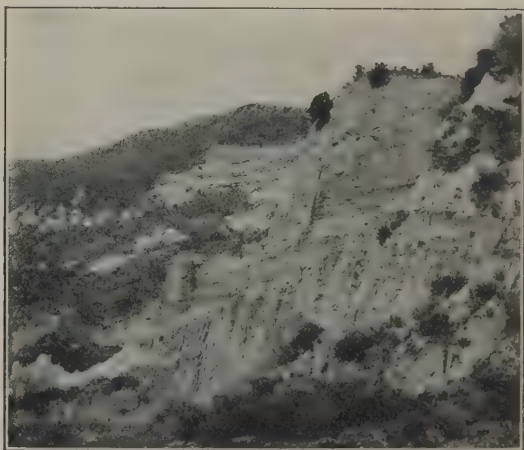
*Fissure and Landslip, San Jacinto Valley, 1897.*

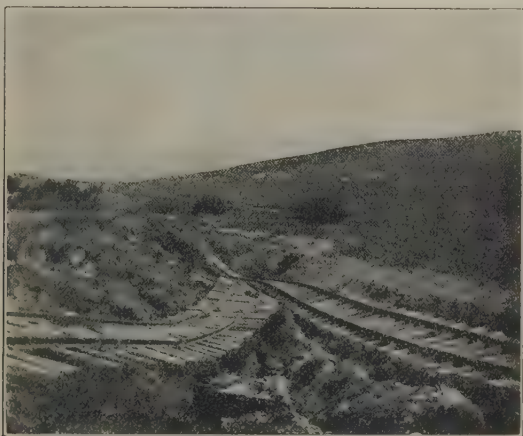
*Tomales, Marin County. The North Shore Railroad and the Earthquake Rift.*

the bay extended along the shores. In the town of Tomales, much and varied mischief was done. The parallel cracks toyed with miles of the North Shore Railroad between Tomales and Point Reyes.

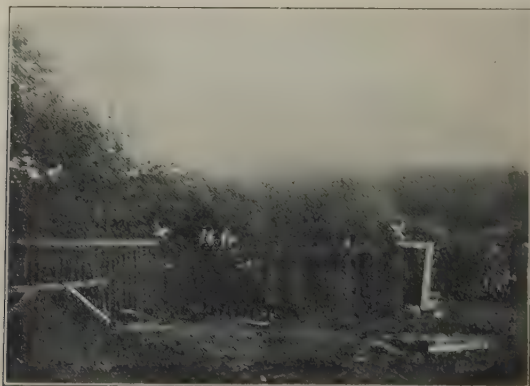
*Point Arena. Picket Fence Was in One Continuous Line. Photograph Shows Short Section Put in To Fill up Offset by Land on the West Side.*

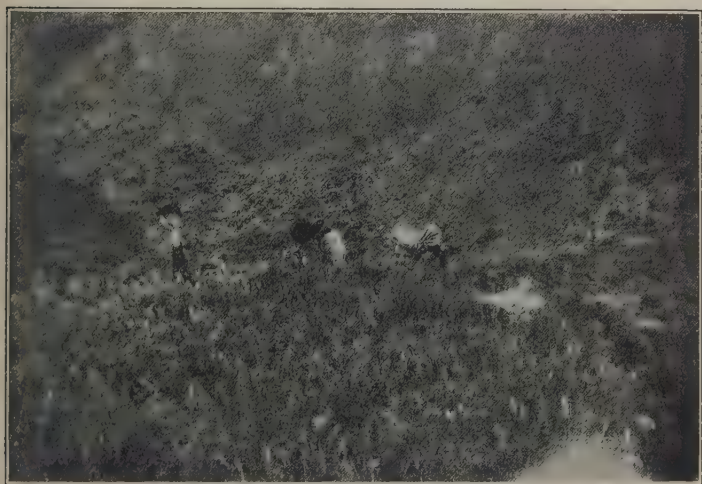
*Landslip at Sobrante.*

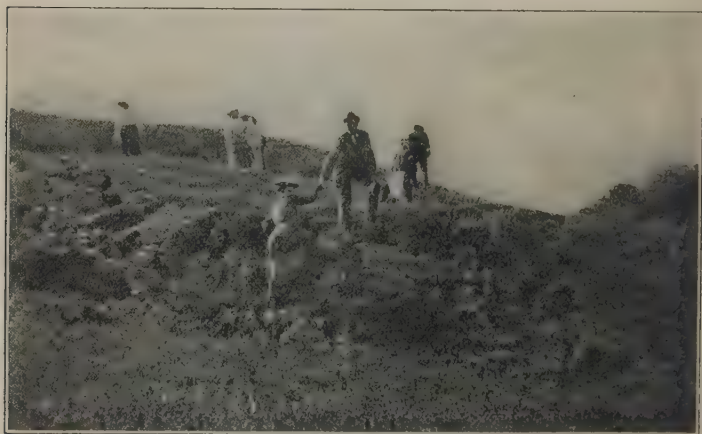
*Landslip at Sobrante.*

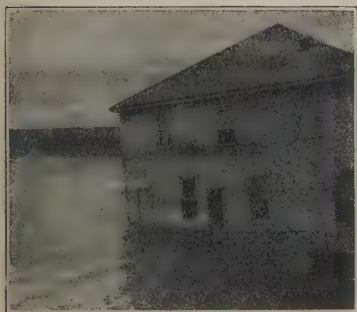
*Marshall Hotel, Thrown into Tomales Bay.*

At Marshall the humble hotel was thrown bodily—and upright—into the bay, the boarders unharmed; and at aristocratic Inverness, on Tomales Bay, three summer cottages suffered the same fate. A fisherman in the bay reports that the waters of Tomales Bay receded, leaving his boat in the mud.

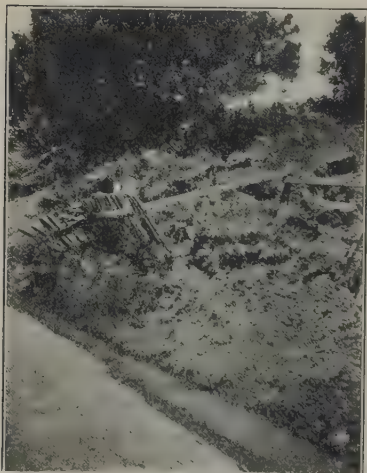
*Earthquake Crack in Country Road from Olema to Point Reyes.*

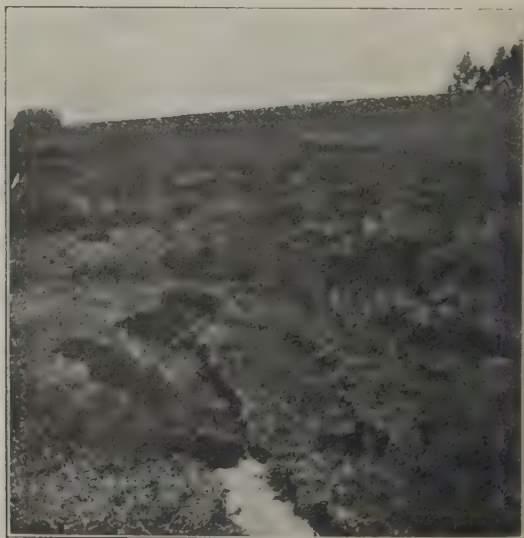
*Earthquake Rift, Freeman's Ranch.*

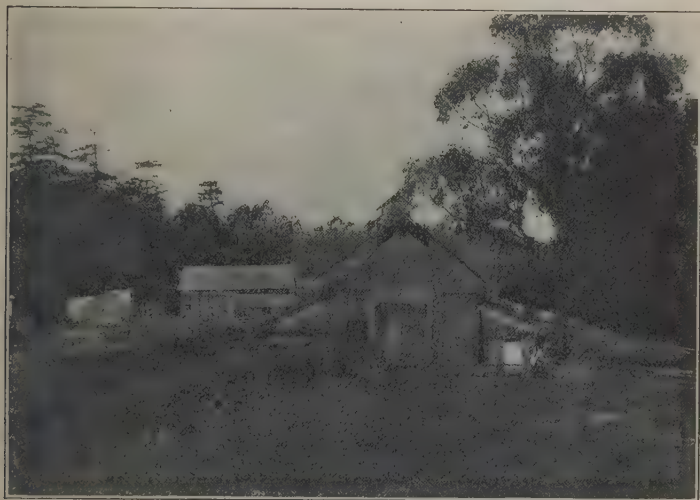
Skinner's Ranch is a large dairy near Olema. The house stands near the road, a dairy house some thirty feet to the south of it, and a large barn with cowyard just behind that. A row of large cypress trees stood just before the house on the roadside, between them and the house a little rose garden, to the south of these, opposite and partly behind the dairy, a group or row of large eucalyptus trees. The earthquake rift passed directly in front of the house, between the buildings and the road. All that stood to the westward of the crack was violently jerked to the north a distance of sixteen feet seven inches, or it may be that the east side moved an equal distance to the south. If Mr. Skinner had chanced to look at the right instant he would have seen the whole row of cypress trees file past his window to take their station in front of the dairy, taking the rose garden with them. A few raspberry bushes came from farther north to take, partly, the place of the roses. The eucalyptus trees in front of the dairy moved on to a position opposite the barn, and one detached from the others and to the westward of the crack was left near the head of the line instead of at its foot. The crack passes obliquely under the barn, entering it at the northwest corner and leaving it at the middle of its pos-

terior or southwest side. The barn remained intact, thanks to its weak foundation, for the east side pulled loose from the ground, and the barn went northward with the west side. Sixteen and

one half feet of its former foundation at the southeastern corner is exposed. A driveway under the barn is divided in the middle. You pass in on the east side, the western half is sixteen and one half feet to the north of the entrance and completely blocked in the middle. Under each of the east windows of the barn stood a pile of manure. Each pile

is intact, sixteen and one half feet south of the window to which it belongs. The people at the ranch were milking at the time of the shock. Each man and cow was thrown to the ground and it took two

hours to get the frightened cattle back into the 'corral.' The stone steps to the basement of the dairy, on the east side of the crack, now stand sixteen feet seven inches to the southward of the door to which they led. About Skinner's, line fences and water pipes crossing the fault were broken, a break of sixteen and one half feet being left

*Skinner's Ranch, Olema.*

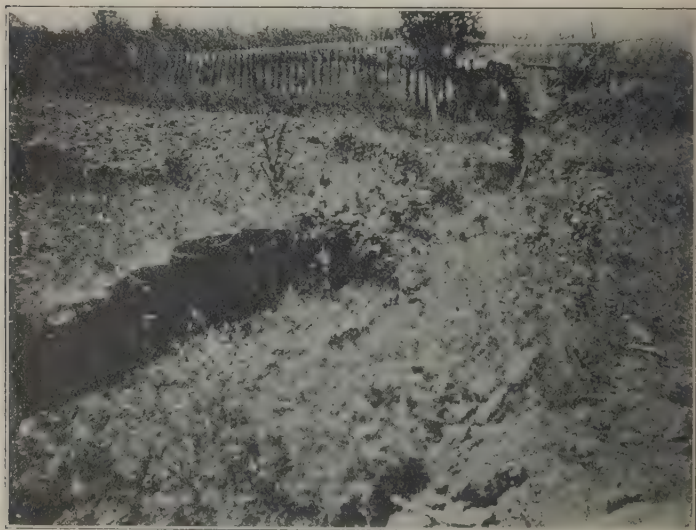
*Earthquake Rift, Morrill's Ranch, Skylands, Santa Cruz County.*

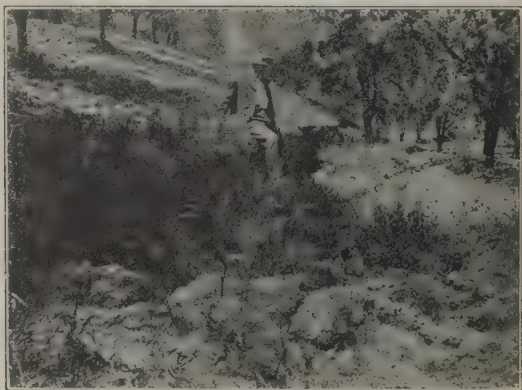
*Earthquake Rift, Morrill's Orchard, Santa Cruz County.*

The earthquake ripped its way through the orchard, shifting the rows of trees six to eight feet and treating roads and fences in the same reckless fashion. The large hospitable Morrill farmhouse stood partly over the track and was split in two and utterly ruined. Farther on at Skylands, on the ridge of the mountains, Fern Gulch was filled with wreckage; redwood trees four and five feet through, two or three hundred years old, were snapped off like

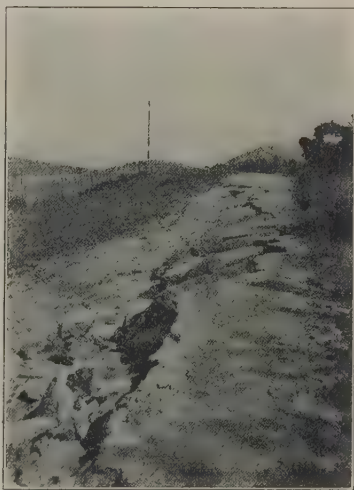
*Inverness Road, near Olema, Marin County.*

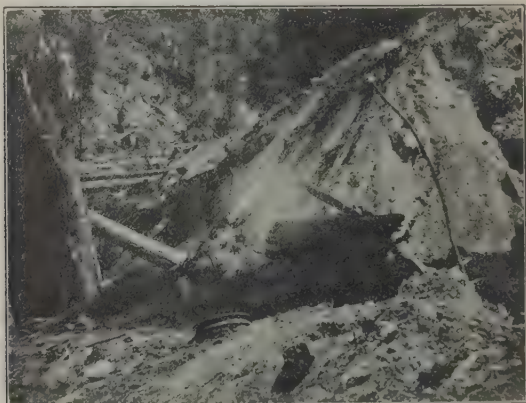
whip-lashes. The rift crossed Hinckley's Gulch at right angles. This is a narrow gorge about a hundred feet deep, in which stood the large Loma Prieta sawmill. The gorge was filled by landslips thrown from both sides. The mill was completely buried, with nine mill hands, and a redwood tree over a hundred feet high was set erect and unhurt over the place where the mill stood. The bodies of six men were recovered. One of these, the foreman, was found erect, smothered in mud, but standing with extended arms and limbs in the act of running from the mill. With him, equally erect and in the act of running was the body of a Siberian mastiff. Their position marked the meeting point of the two walls of the cañon. The crack went on across the hills, always in the same direction, southeast by south, till it came to the Chittenden Ranch in the Pájaro Valley. Here it tore off the hillside,

*Wreck of Loma Prieta Sawmill, Hinckley's Gulch, Santa Cruz County.*

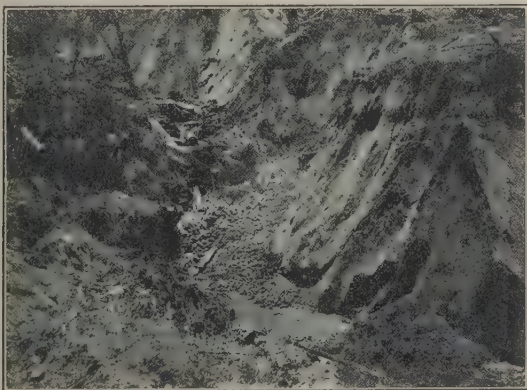
*Site of Loma Prieta Sawmill, Covered to the Depth of 125 Feet.*

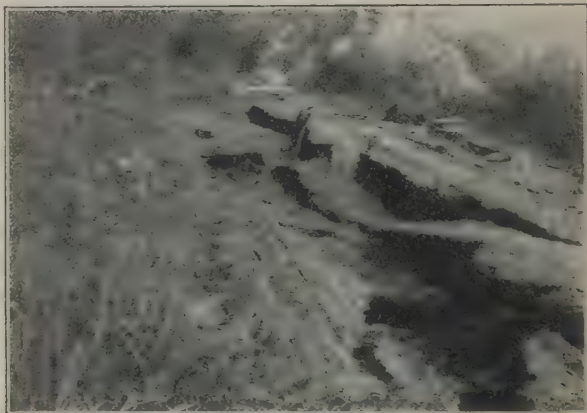
*Slump in Soft Ground, Milpitas.*

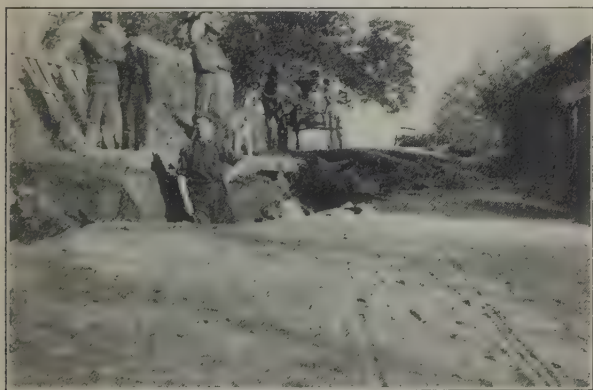
*Rift Crossing Road near Skylands, Santa Cruz County, Showing  
Relative Sinking of West or Uphill Side of Rift.*

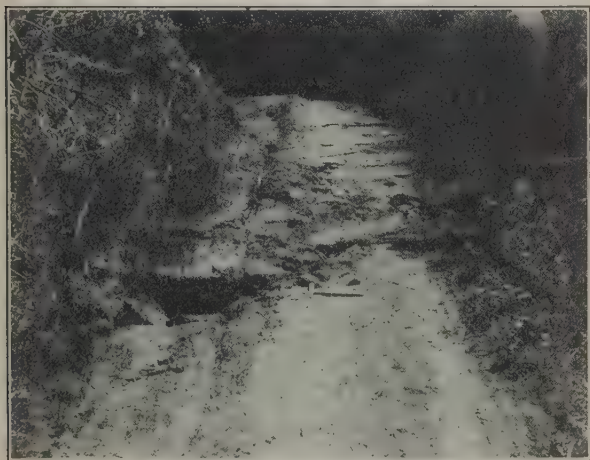
*Rift Across Road near Azul Springs, Santa Clara County.*

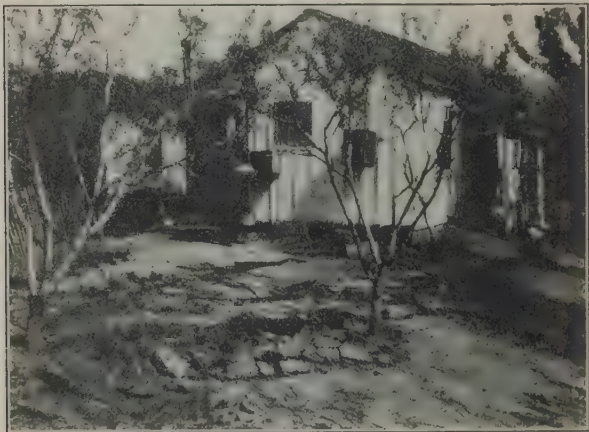
*House over Rift near Saratoga Springs, California.*

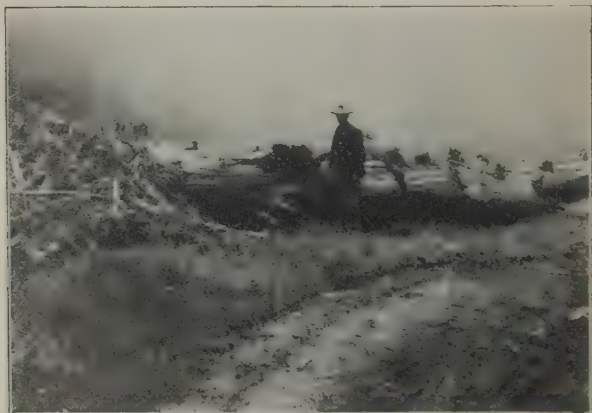
*Redwood Snapped Off by Earthquake near Fort Ross, Cal.*

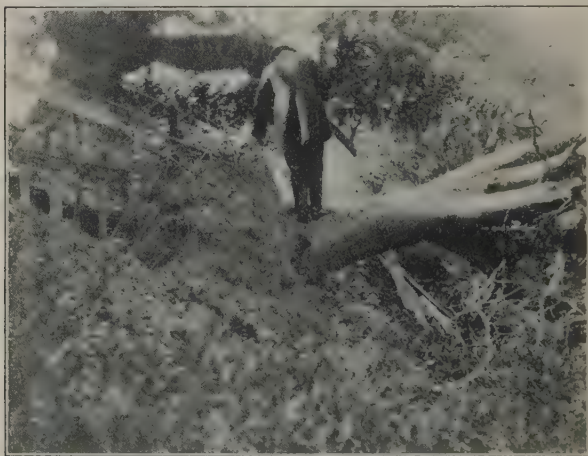
*The Fault Passes Under a Live Oak and Uproots It, Woodside, Cal.*

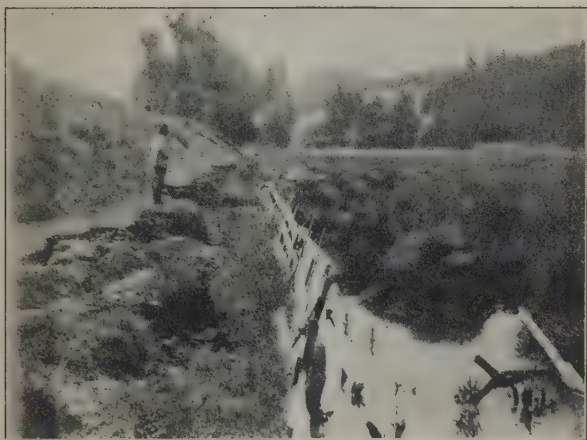
*Rift on Shafter's Ranch, Olema, Cal.*

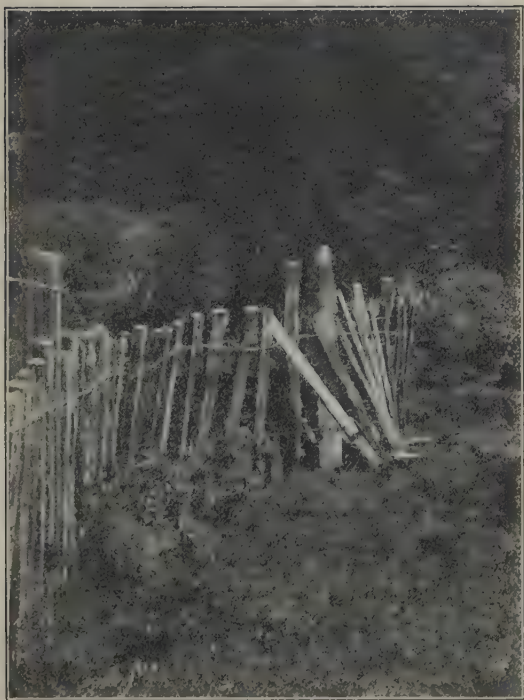
FIG. 5.—Fence near Fort Ross, Sonoma County, California, Offset Nine Feet at the Line of Fault.

the resulting displacements mentioned. The tearing of the surface along the fault also clearly shows that there was some torsion in a clockwise direction when the eye looks downward. Fig. 5 shows a fence one-half mile south of Fort Ross which did not collapse, but was curved and bent to suit the lateral movements of the earth, so that its unmoved parts are now nine feet out of alignment. A second fence one-half mile farther south completely collapsed for a few feet on each side of the fault and was offset fifteen feet six inches. Near the head of San Andreas Lake a fence, Fig. 6, was offset seven feet. A roadway in the Point Reyes locality was dislocated about twenty feet. In all cases the west side moved north.

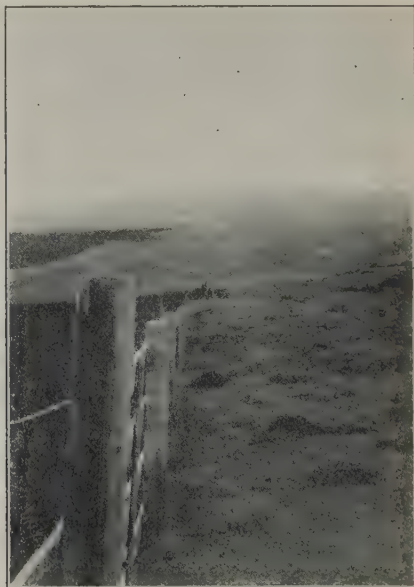
FIG. 6—Fence near the North End of San Andreas Reservoir, San Francisco Peninsula, Offset Seven Feet at the Line of Fault.

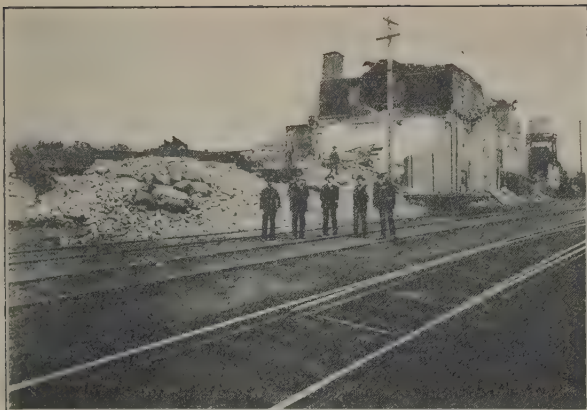
How then should the general destruction be explained? The brick buildings of Santa Rosa were carelessly constructed. Lime mortar was almost invariably used with bad brick bond. The sand of the lime mortar used was what is locally known as "drift" sand, containing, according to a local engineer, practically fifty per cent of loam. When we remember that it has been too common a custom in California to lay brick for small structures without sufficiently wetting them, in fact almost dry, what else should be expected, especially when we further observe a most inadequate anchoring of the floor and roof frames to the outer walls, and a usual absence of necessary cross walls or frames. Besides brick buildings are not capable of withstanding heavy earthquake vibration. It is a fault of design more than of workmanship. Upon this

FIG. 7—Santa Rosa Flour Mill. A Typical Brick Structure with Wooden Interior, Three Stories in Height; the Major Portion Completely Collapsed.

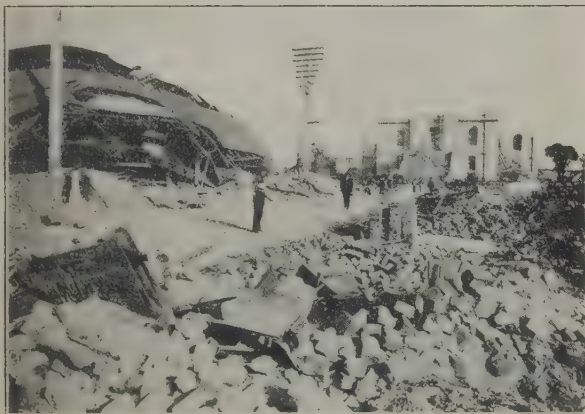
FIG. 9—A Scene in Santa Rosa Photographed Shortly after the Earthquake and Fire. The View Shows the Corner of Fourth and Mendocino Streets. The Ruins of the Court-House face Mendocino Street. On the Left in the Picture Is Seen the Collapsed Keegan-Brush Building, a Two-Story Brick and Stone Structure, Devoted to General Store Purposes. This Building Did Not Burn, and Ninety Per Cent of the Stock Was Saved. On the Right Side of Mendocino Street the Fire Destroyed Everything. In This Respect the Picture Is Instructive in That It Shows the Difference in the Destruction by Earthquake and Fire.

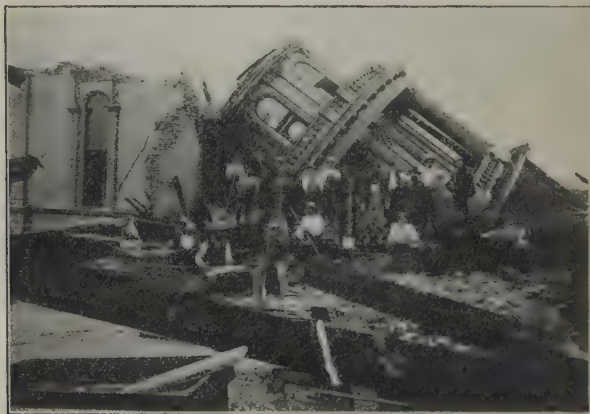
FIG. 10—*The Collapsed Court-House Dome, Santa Rosa. The View Is Taken with the Camera on the Second-Story Roof; See Fig. 9. The Court-House Consisted of Three Stories of Brick, the Third Story Smaller in Plan Than the Other Two. The Third Story Supported the Wooden Dome.*

the water works system, its artesian sources of supply, or its pumps. A few house-service pipes broke at the house lines. No sewers were crippled. It is plain to me that there was little or no unequal resultant movement of the ground at Santa Rosa such as one finds at the fault line. The destruction was due merely to earth vibration and the brick

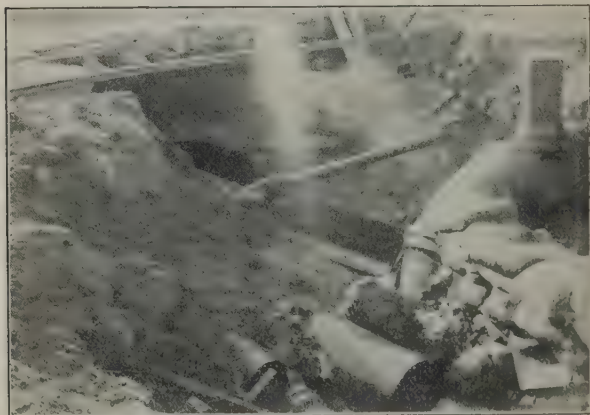
much greater resisting qualities, but I am convinced that even such material could not withstand earthquake stresses on the dividing line between made and filled ground. At such points flexible joints might have helped the sewer and water pipes, but it is difficult to conceive of a practical means for procuring flexibility at any given

FIG. 13—Scene Corner of Howard and Seventeenth Streets Showing Rupture of Car Tracks, Sewer, Water and Gas Pipes.

point in a brick or concrete sewer. Moreover, it would be requiring a power of prediction not resting in human beings to determine the proper locations for flexibility. Important water pipes wherever possible should avoid soft ground by going

around it, and those that must traverse filled areas should be of riveted steel or wrought iron with flexible joints at intervals. Greater probability of resistance to rupture might be further insured by encasing pipes traversing the most treacherous ground in tunnels of reinforced concrete with suitable clearance between the pipe and the tunnel

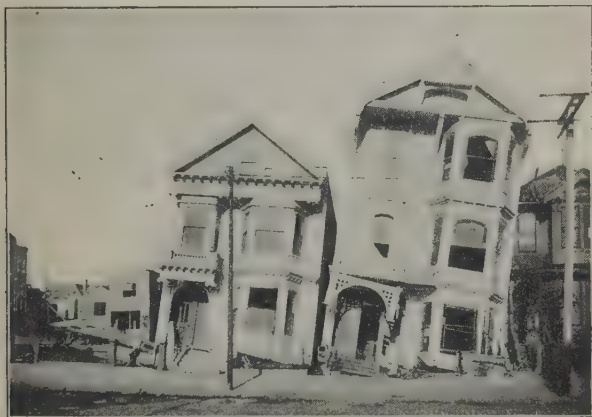
FIG. 14—Collapsed Frame Houses on Howard Street, between 17th and 18th Streets. The One on the Left Is Completely Razed. At This Place the Earth Movements Were Especially Severe, and Even Good Construction Would Have Suffered.

Many frame buildings collapsed on the filled ground, Fig. 14; and an unreasonably large number on the more substantial areas of the city. Some of the destruction in the made land district was unavoidable, but much of the general collapse of frame houses was due to improper underpinning in the foundations. Such houses virtually stood on stilts; consult Figs. 15 and 16. Moreover, the cheaper frame buildings were provided with carelessly constructed brick chimneys built with weak lime mortar; naturally the brick work cracked to pieces. It is therefore easy to see why so many of these houses burst into flames immediately after the earthquake. It is said that fifty-seven fire alarms were sent to the Fire Department within the first half hour. Of course not all of these fires were produced by fallen or cracked chimneys in frame buildings. Some were similarly started in cheap brick structures, which are just as readily inflammable,—and still others by the breaking of electric wires of high tension, or through improper electric insulation of power wires.

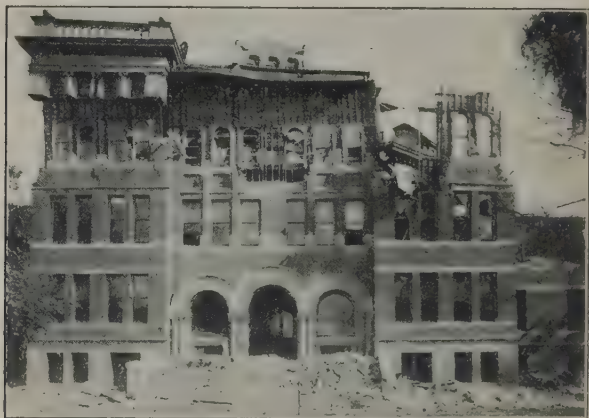
The prime requisite for a structure to withstand earthquake shock is elasticity; that is, the ability to return without serious damage to its original shape and position after being distorted. It should vibrate without offering great resistance to distortion; in other words, it should yield readily. The wooden framed and the steel framed building answer this requirement. To an almost equal extent the reinforced concrete building does so also. But structures of brick and stone built of blocks, like brick work and cut-stone masonry, with horizontal and vertical mortar joints do not answer the requirements of yielding and elasticity to any desirable degree. This is especially true when the interior framing is of wood and of the weak and faulty design depicted in the preceding paragraphs. Brick and stone walls when not sufficiently reinforced and intelligently strengthened and supported by steel framing are inadequate for import-

ant buildings in an earthquake country. Consult Fig. 17.

FIG. 17—*A San José High School. Ordinary Brick Construction with Wooden Interior.*

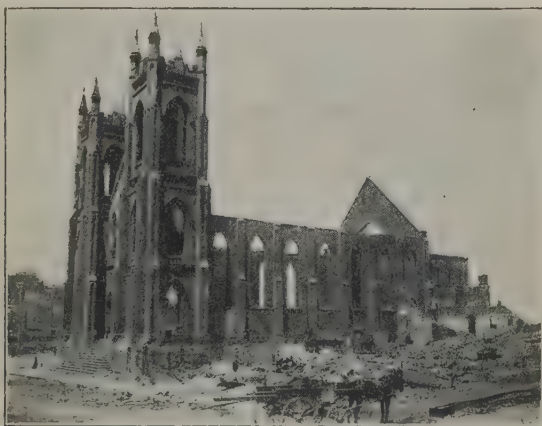
FIG. 18—*St. Francis Church, San Francisco; an Example of Excellent Brickwork.*

damage. I refer to several churches, see Fig. 18, to the Custom House or Appraiser's Building and to the Palace Hotel. The walls of the Appraiser's Building were thirty-six inches thick. The Palace Hotel was built immediately after the earthquake of 1868 and was intended to be earthquake-proof. The outer walls were most carefully designed, the window openings were crowned with arches and

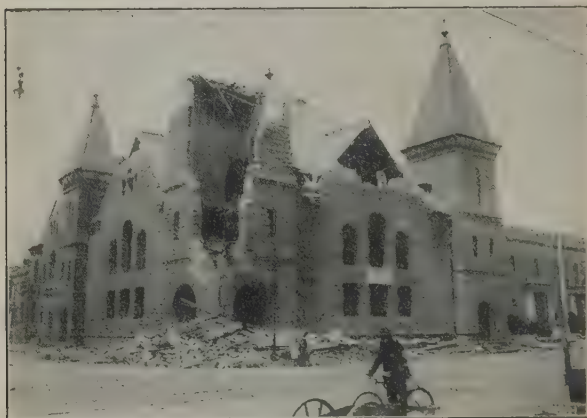
FIG. 19—First Baptist Church, Oakland, California. The Dangerous Tower Was Pulled Down Several Days after the Earthquake.

tied to the interior floor and roof frames, suffered severely throughout the earthquake belt; see Fig. 8. Too many structures of this type for architectural reasons are made top heavy; see Fig. 19. Much of the recent construction at Stanford University may be criticized along these lines. In Oakland, Berkeley and San Francisco, heavy masonry church towers were invariably demolished, except where they were properly reinforced by interior steel frames or were strengthened by interior cross walls and tying rods. Heavy stone ornamentation should be discouraged and heavy stone cornices should be avoided. Where architectural effect is insisted upon, no expense should be spared in anchoring heavy stone cornices by the use of metal.

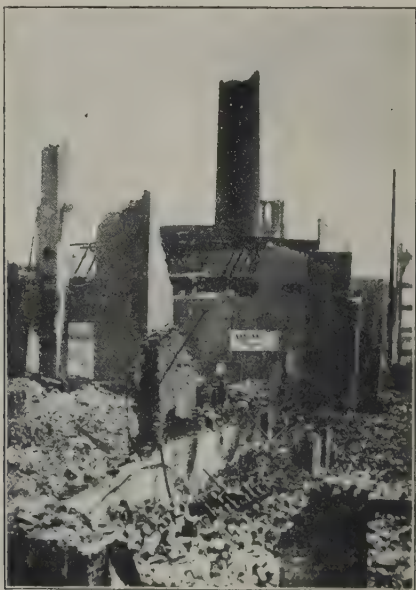
Chimneys in San Francisco were built of brick and very often without cement in the mortar. With few exceptions the chimneys were thrown down by rupture within the middle third of the height. A number of lives were lost by falling power house chimneys; see Fig. 20. In the future I believe chimneys should be built of reinforced concrete and not of brick. Where brick is insisted upon, the bond should be carefully provided for, the mortar should be rich in cement and there should be some metal reinforcement.

FIG. 20—*Fire Ruins of a Power-House of the San Francisco Gas and Electric Company, Station C. The Chimney of This Structure Fell During the Earthquake Shock, Demolished a Part of the Equipment and Killed One Person.*

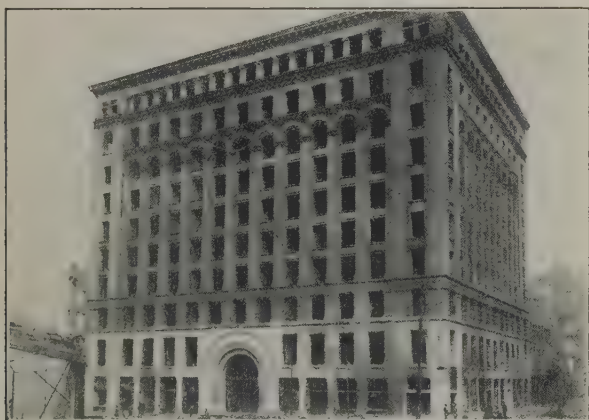
certainly should not advocate self-supporting walls for earthquake countries. The Mills Building in San Francisco, Fig. 21, an otherwise excellent structure of ten stories, was designed with self-sup-

FIG. 21—*The Mills Building, San Francisco; Self-Supporting Brick Walls, Interior Framing of Steel, Floors and Partitions of Hollow Tile.*

porting walls and with main columns breaking joints at every floor level. After the earthquake the walls of this structure leaned from seven to nine inches into Bush Street. While the structure did not appear to be severely racked by the earthquake, the fact that the walls bore little relation to the interior frame, and the interior frame lacked continuity of columns at every floor, would not lead

me to recommend such a type of structure for an earthquake country. Moreover, the type exhibits great weakness in resisting fire because the walls tend to leave the frame. In Class B buildings it was a general observation to note heavy cracks run-

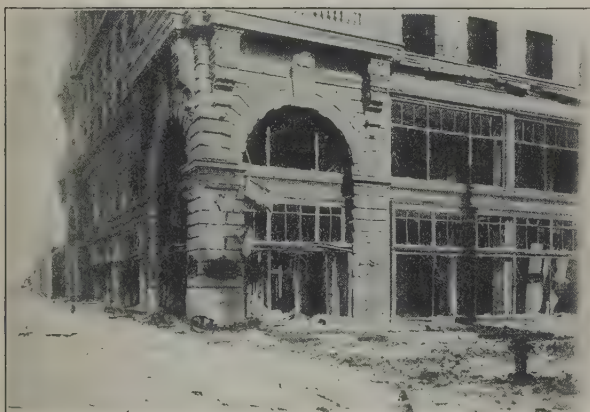
I have already stated that in high buildings the earthquake racking was most severe near the street level. One found in nearly every Class A building

prominent cracks in the first story walls (Fig. 24), especially at points where heavy weights were concentrated upon corner columns. The stone work of corner columns was severely cracked where the masonry rested upon concrete under the sidewalk,

FIG. 24—*Flood Building, Northwest Corner, Showing Heavy Earthquake Cracking of the Sandstone Masonry Enveloping the Steel Corner Column.*

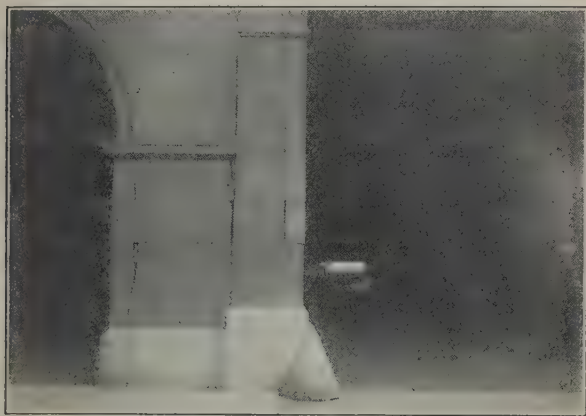
*FIG. 28—Earthquake Cracks on Sandstone Piers of the Ferry Building. These Piers Enclose Steel Columns with a Complete Air Space between the Steel Columns and the Stone Blocks. This Explains the Large Amount of Cracking and Shows That the Stone Piers Are Not Required for the Support of the Second Story.*

bear against the structure from the land side, tending to thrust it into the bay. The building rests on piles in large clusters, and withstood its severe test admirably. The top of the south end wall fell out. The stone work near the street level on the main pilasters was badly cracked (Fig. 28). In the second story horizontal joints were opened throughout the west front length of the building. The marble plates on the interior walls were much broken. The tower was shaken like a tree or flag-pole in a vertical plane east and west, nearly coincident with Market Street's length. The east and west faces of the tower were therefore badly racked, just above the roof of the main building, and the stone facing at these places was thrown down, causing considerable destruction in the interior in the central portion of the building below the tower, see Fig. 29. The upper portion of the tower was originally designed in stone, but the consulting engineers advised the substitution of metal sheeting to reduce the weight, and this fortunately was done. Had the upper portion of the tower been of stone, I believe the destruction would have been very much more serious. The stone facing of the tower was backed with brick, and this masonry was supported by a steel frame, as in Class A buildings. It appears that the steel frame was built too light, especially the diagonal members. These

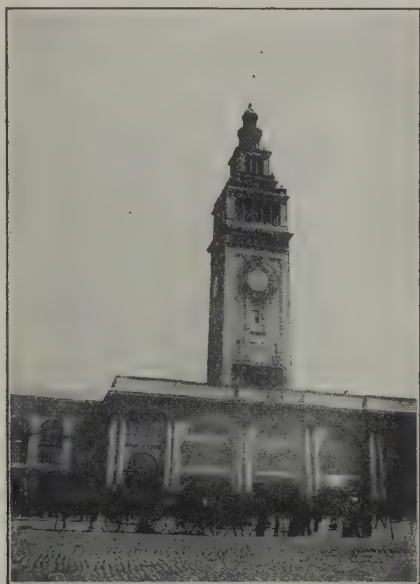
diagonals should have been heavier, and of stiff sections instead of rods. Some of the diagonal rods were snapped and some gusset plate connec-

FIG. 29—*The Ferry Tower Shortly after the Earthquake.*

tions and riveted joints were ruptured. I have already referred to the superior merit of quadri-lateral framing, using spandrel girders and knee bracing. The tower was rapidly dismantled, the

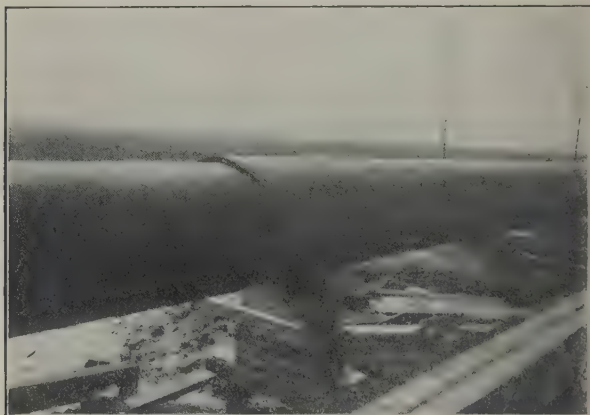
FIG. 31—Rupture of the 44-inch Crystal Springs Conduit on the San Bruno Marsh; Picture Taken May 2, 1906. The Wooden Supports under the Pipe Are Temporary Forms Built after the Catastrophe. The Pipe Has Been Straightened Preparatory to Repairing the Transverse Riveted Joints.

the trestle moved with mother earth. The pipe, due to its inertia, tended to remain quiet. As a result the pipe was alternately thrown from one side to the other of the trestle floor and its wooden box covering was generally smashed. The pipe broke at transverse circular riveted joints, sometimes by tension, and sometimes by crushing. Fig. 31

exhibits a view of one of the ruptures on the San Bruno marsh. Figs. 32 and 33 show other scenes along this pipe line during the period of repair immediately following the earthquake. Redwood planks were used for the temporary sills and stringers because larger timber was not quickly available.

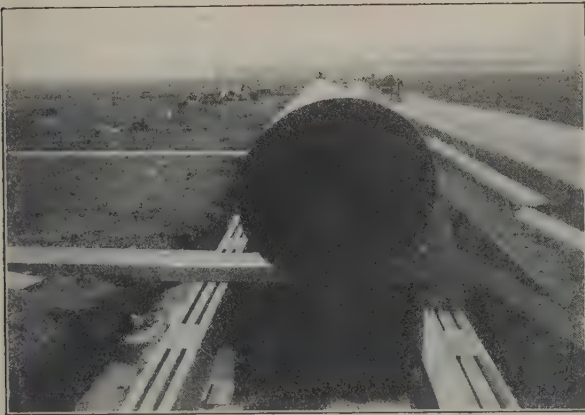
FIG. 32 *Rupture on Crystal Springs Pipe Line, San Bruno Marsh.*

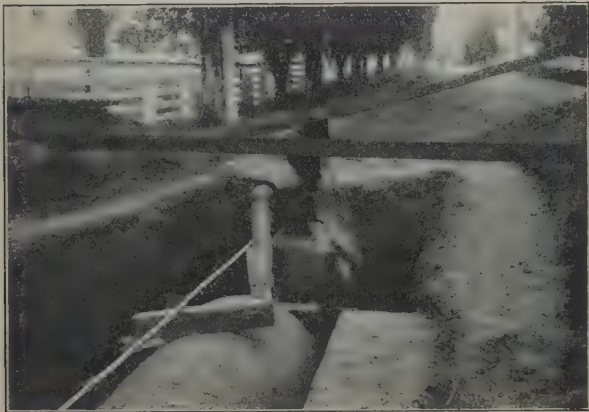
FIG. 33—*Crystal Springs Conduit between San Mateo and Millbrae. Temporary Cut-Off to Stop the Flow of Water toward San Francisco and Yet Maintain a Pressure and Supply for the City of San Mateo.*

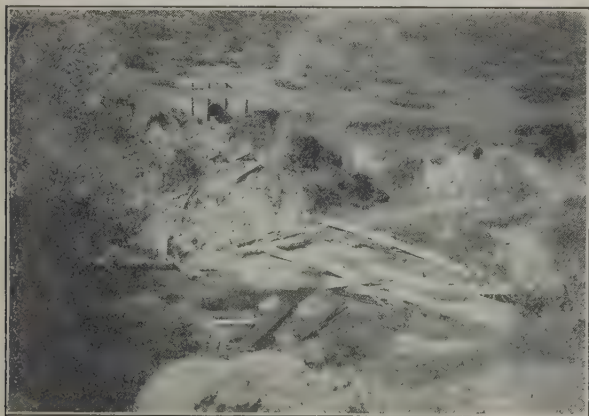
FIG. 35—*Collapsed Trestle at Frawley Gulch, Pilarcitos Pipe Line, Spring Valley Water Company.*

about 100 feet in length and some 25 feet in maximum height. Some of the timbers of this trestle were partly decayed, but the structure certainly was not weak. This trestle was about  $\frac{1}{4}$  mile to the east of the fault line. Nevertheless the shock was so severe that it entirely demolished the trestle and pipe which it carried. The trestle probably vibrated in a vertical plane normal to its length,

and was thrown down-stream to the southeast, as shown in Fig. 35.

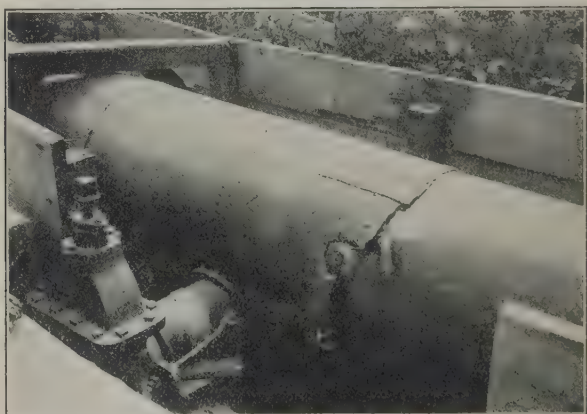
FIG. 36—Telescoped Rupture, Pilarcitos Pipe Line, Spring Valley Water Company.

Figs. 36, 37, 38 and 39 show additional ruptures in the Pilarcitos pipe line between San Andreas Lake and Frawley gulch. In Fig. 36 the pipe line,

to the north of the break in Fig. 36. At the point where the man is standing the fault line crosses the pipe line at an angle of  $45^{\circ}$ . The pipe was sheared so that its parts are 20 inches out of alignment, and are moved toward each other 40 inches.

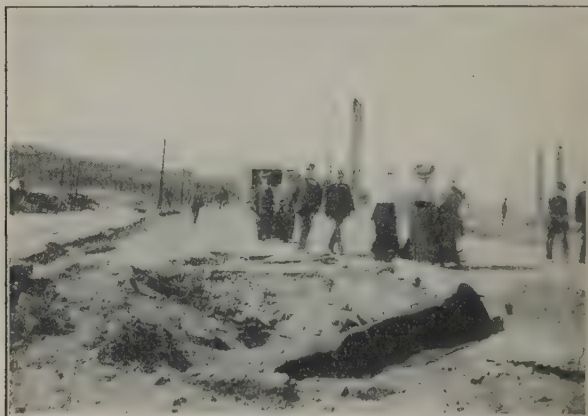
FIG. 40—Gas Main Explosion, Valencia Street, near Market Street, San Francisco.

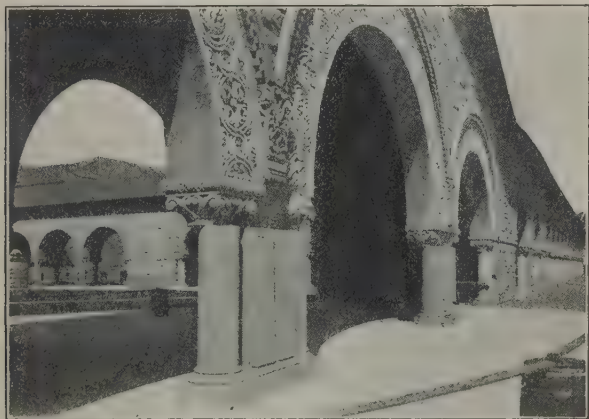
FIG. 41—Arcade, Inner Quadrangle, Stanford University.

tion. I consider the third reason by far the most important. Heavy stone-faced buildings of the type we find at Stanford, no matter how well built, cannot resist an earthquake of the intensity experienced at Palo Alto, when we consider the nature of the ground upon which the buildings rest. Top-heavy stone arcades and walls, supported by light masonry pillars, see Fig. 41, are not constituted to

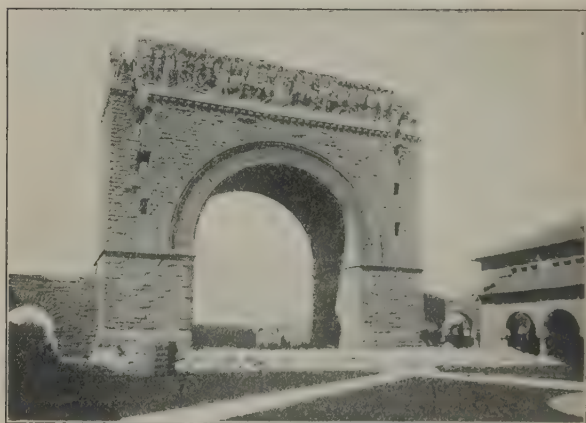
FIG. 42—Rear View Memorial Arch, Stanford University, Showing Arch Ring Intact.

I have seen many pictures of the Memorial Arch showing dramatic destruction. These pictures give a false impression. Fig. 42, a view of the rear elevation, shows that the arch ring itself was not thrown down; in fact, there were but a few cracks in the crown of the soffit. It was the heavy top and cornice, insufficiently tied, that fell, as they should. It would have been surprising had they not fallen. Above the arch was a large box-shaped mass of masonry upon which rested the heavy overhanging cornice, and this box had practically no transverse framing or partition walls of any kind. The masses that dropped from the arch fell in large pieces, nearly 100 feet to the pavement without crumbling, Fig. 43, which proves that the mortar was good. Considerable cement was used in the mortar for the

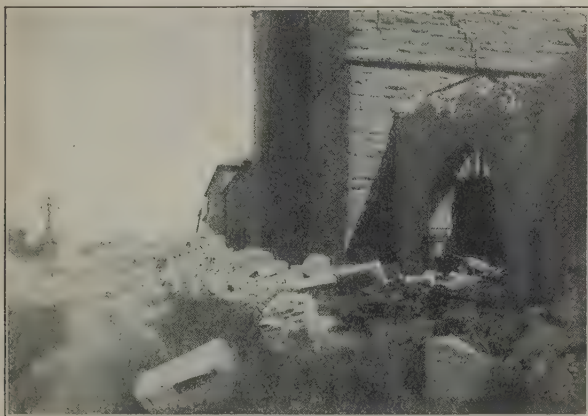
FIG. 43—*Fallen Masonry from Top of Memorial Arch, Stanford University, Showing Mortar Strength.*

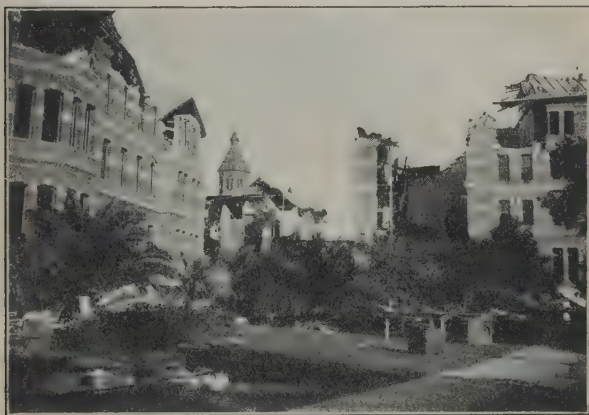
FIG. 44—*View at Agnews Showing the Complete Collapse of the Main Tower of the Asylum.*

seriously to realize the situation? The main central brick structure and tower of Agnews Asylum, Fig. 44, entirely collapsed. The central tower fell en masse and crumbled to pieces so that three distinct wings of the buildings, themselves much demolished, were left disconnected. Some of the outer, smaller buildings had nine-inch brick walls

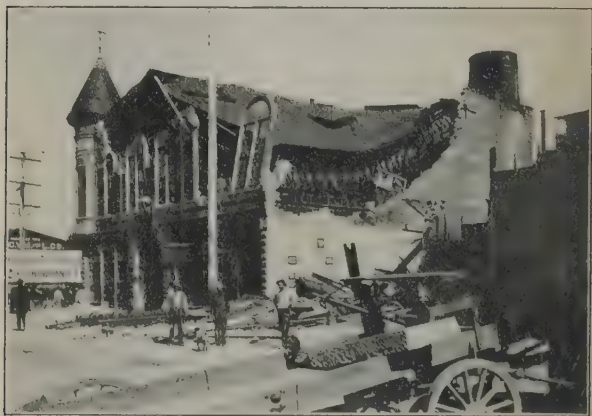
FIG. 45—Earthquake Destruction, Native Sons' Hall, San José.

San José, about forty miles to the south and east of San Francisco, is thirteen miles to the east of the fault line. This city fortunately was spared a conflagration. The earthquake destruction was appalling, as is shown by a few typical photographs; see Figs. 45, 46, 47, and 48.

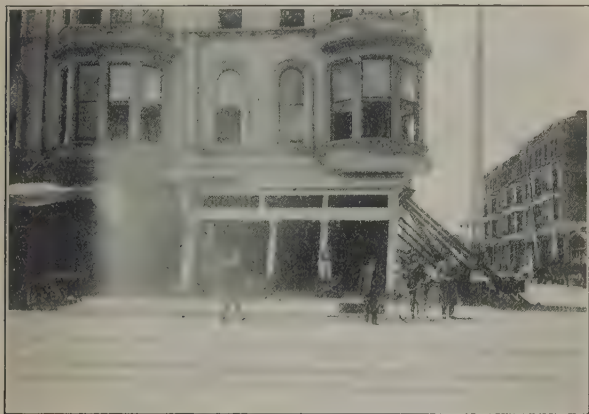
FIG. 46—*A View on First Street, San José, Showing Lack of Framing for First Floor. These Buildings Were Later Pushed Back into Place.*

San José's water works, like that of Santa Rosa, was not injured; its sewers also were left intact, showing that there was no unequal displacement of the ground. The earthquake destruction was the result of severe vibration of poorly constructed brick and stone buildings. Again we find cheap construction with lime mortar, weak framing and insufficient anchoring for floors and roofs. Whole sides and fronts of two and three story store and office buildings on the main business streets collapsed; Fig. 45. On First Street, in the main business center, in one instance, a row of about six or seven buildings careened, due to a lack of sufficient transverse framing in the first story. Stores

occupied these main floors, demanding large window openings and as much floor space as possible. Virtually the upper portions of the buildings rested on stilts; see Fig. 46. Public buildings in San José, with the exception of the postoffice, were

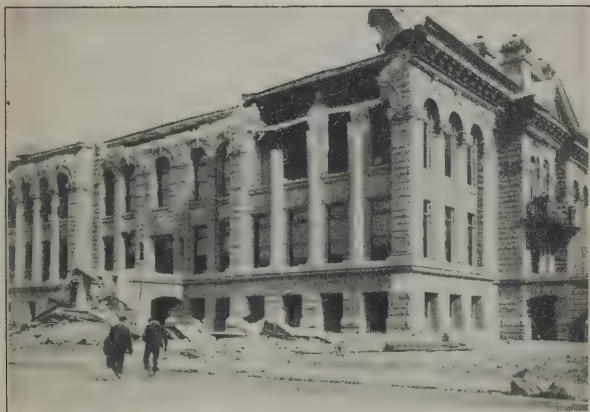
FIG. 47—*Hall of Justice, San José, Completed in 1905.*

generally racked. The tower of the postoffice was thrown down. In too many instances we find heavy stone facings improperly anchored to the interior frames, and roofs without system. In the great area of destruction, one finds roofs depending for their support upon the stiffness of the walls upon which they rested, while from the nature of design and construction the walls lacked stiffness. These

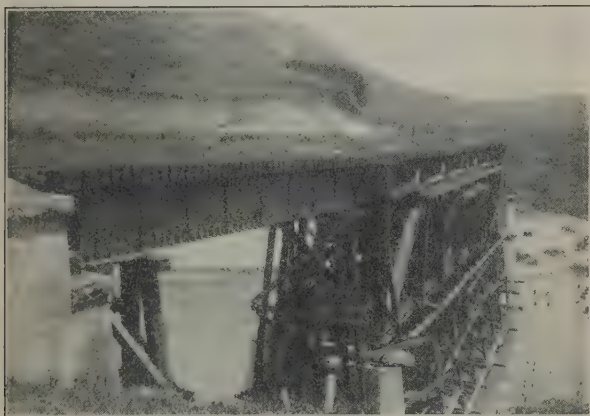
FIG. 49—Pájaro River Bridge, Southern Pacific Railroad; Temporarily Strengthened by Timber Bents and False Work; View Taken May 30, 1906.

It is on a six-degree curve whose chord makes an angle of about  $40^{\circ}$  with the fault line. The fault crosses the bridge near the west end. The bridge consists of two end deck-plate girder spans of fifty feet each, and four intermediate deck Pratt trusses, each of 120-foot span; Fig. 49. The abut-

ments and the intermediate piers are of concrete with granite copings. This structure, in my judgment, would not have been affected by the earthquake had it been at a reasonable distance from the fault line, but it was subjected to a most severe

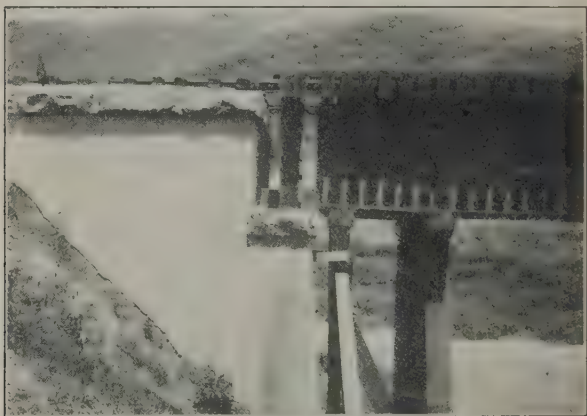
FIG. 50.—*West Abutment, Pájaro River Bridge, Southern Pacific Railroad.*

racking, since the ground upon which its piers rested moved unequally. The distance between the end piers was increased  $3\frac{1}{2}$  feet. All the piers and abutments were moved more or less, but the heaviest movements occurred at the west end of the bridge. Fig. 50 shows the west abutment where the steel plate girders were moved 24 inches off the abutments and had to be supported by a

temporary wooden bent. The plate girder span resting on this abutment did not fall during the earthquake, although it was dragged off the bridge seat, because it was held up by the rail fastenings and the riveted connections to the next span to the

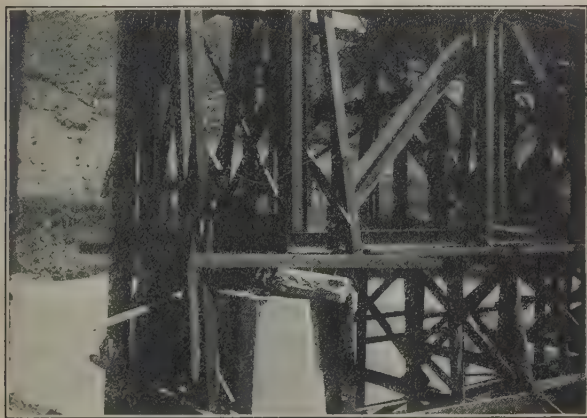
FIG. 51—*First Intermediate Pier, West End, Pájaro River Bridge, Southern Pacific Railroad.*

east. Fig. 51 shows the first intermediate pier at the west end of the bridge. This pier near its base was ruptured in a horizontal section, probably a level between two days' concrete work. The mass of the pier above the rupture was moved eastward about three inches with respect to the base. The coping was ripped from the top and moved

eastward relatively more than 20 inches. The segmental rollers and the steel pedestals upon the coping were smashed and the anchor bolts severely bent. The next intermediate pier leaned somewhat to the east, and the anchor bolts above the coping were bent so that the pedestals of the steel work were moved some three inches. The distortion was less as one approached the eastern end of the structure. The eastern abutment was considerably cracked. The whole bridge superstructure was thrown slightly out of plumb. Earth motions are clearly seen in Fig. 50, where the sloping earth was moved 18 inches along the side wall of the west abutment.

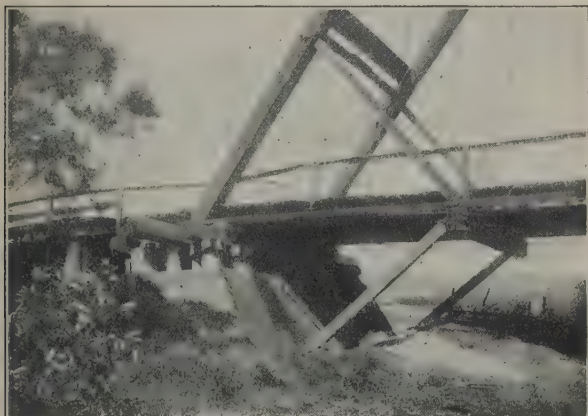
direction a distance of about six feet. Fig. 52 shows the south abutment of the Salinas highway bridge. The ground under the superstructure moved about six feet, careening the pile foundations as shown in the picture, without seriously injuring

FIG. 52—South Abutment, Salinas Highway Bridge.

the trusses. A three-inch oil pipe line which crossed the bridge was ruptured on the south approach, one length of pipe being bent to form the letter "S." The northern approach to the bridge was hardly affected. In fact, the northern bank of the river shows little disturbance at this point. From the Salinas bridge eastward, a distance of about  $1\frac{1}{2}$  miles to Spreckels, the south bank of the river is

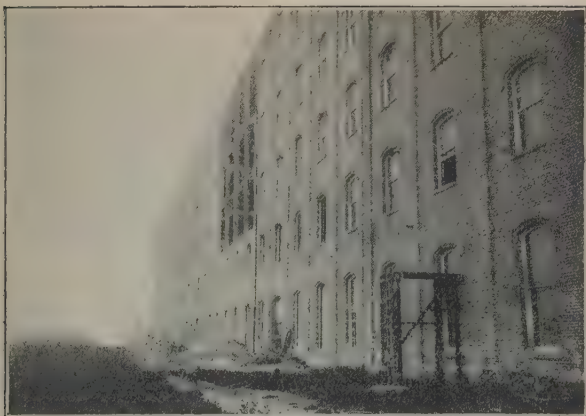
FIG. 53—West Wall, the Spreckels Sugar Mill, near Salinas, Showing Bulged Wall and Brickwork Thrown from the Steel Frame.

The east wall was buckled concave outward, and was badly cracked, but little of it fell. The west wall, in the middle third, was buckled convex outward, and naturally the brick work was thrown down in large masses. Fig. 53 shows the west

wall of the building. I believe this building was subjected to an earth movement from south to north, which accounts in a measure for the buckling of the long walls in the middle unsupported third. There may have been some settling of the walls also. Large masses of brick in the north wall, Fig. 54, were thrown down. Fig. 55 shows a rupture in the carriage way to the dumps at the south
